Safe Regeneration of DPF

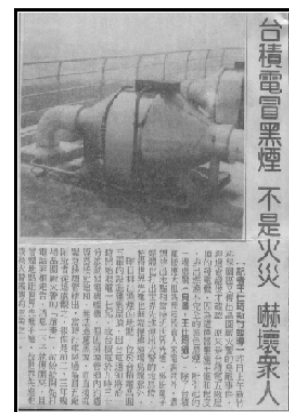
- The potential fire hazard of the filter frequently caused by the incorrect design of filter regeneration; over sooting of filters and improper use of Cordierite substrate, which has less strength and thermal properties than SIC-DPF. These are the root causes of cracked or melted filter, especially when the engine is running continually at full load with very high exhaust temperature.
